Research Report
KTC-99-53

EVALUATION OF SUPERPAVE IN KENTUCKY

September 1999

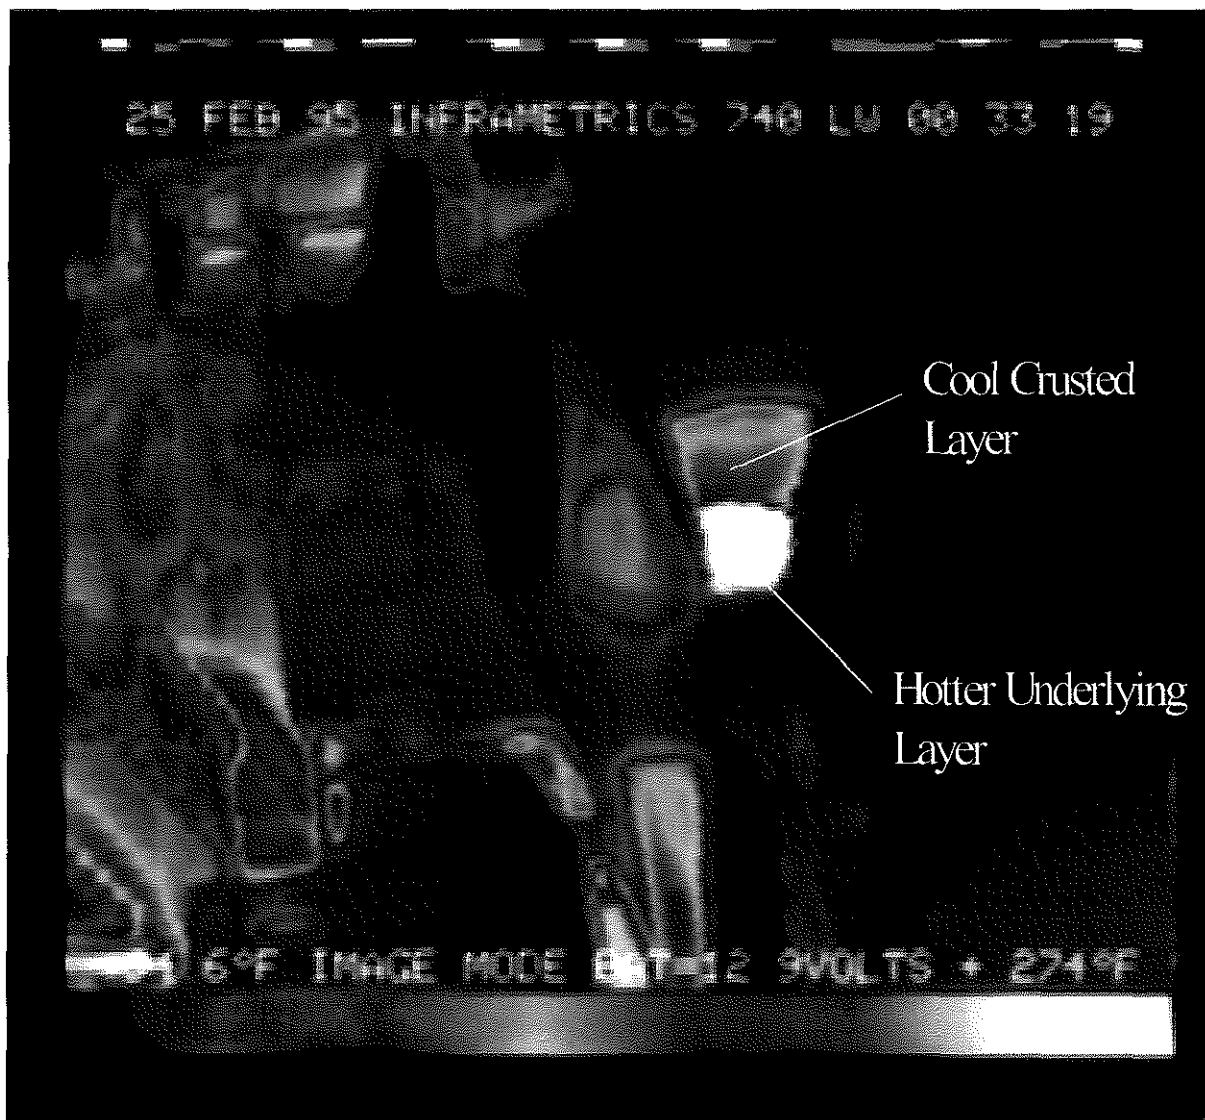
Figure 16. Truck Loading Into MTV.

Thermal segregation was observed during the placement of both base and surface courses on several Superpave projects. Temperature differentials of approximately 50 to 60 °F were observed. Thermal segregation appears to occur during transport and placement. The outer layer of the mixture in the trucks cools more rapidly, crusting over during transport. During the unloading process from the truck to the hopper, the cool outer layer (crust) appears to slide off the hotter mix and enters the hopper first when the bed of the truck is fully raised in one movement. This occurrence is shown in Figure 16 as the truck is dumping into the hopper on the MTV. Temperature differentials appear to be greater with increased coarseness of the mix.
